THE CHALLENGE OF INSPECTING PIPELINES WITH 'UNKNOWN'S'

By: Geert Bontekoe, Quest Integrity, USA and Danny Molyneux, Quest Integrity, UK

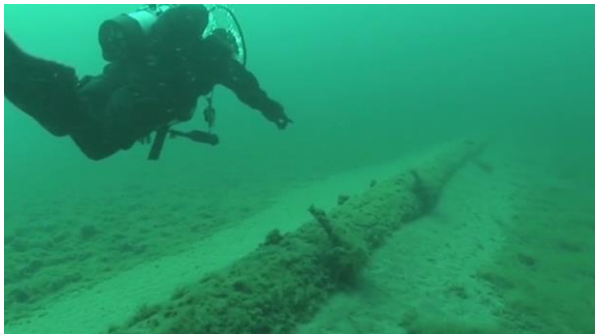
Figure 1: Pipeline partly buried in the seabed

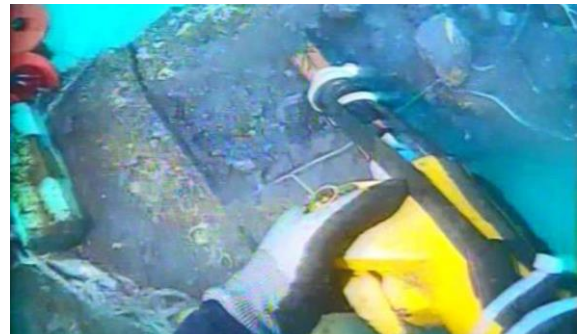
Figure 2: Removal of concrete coating

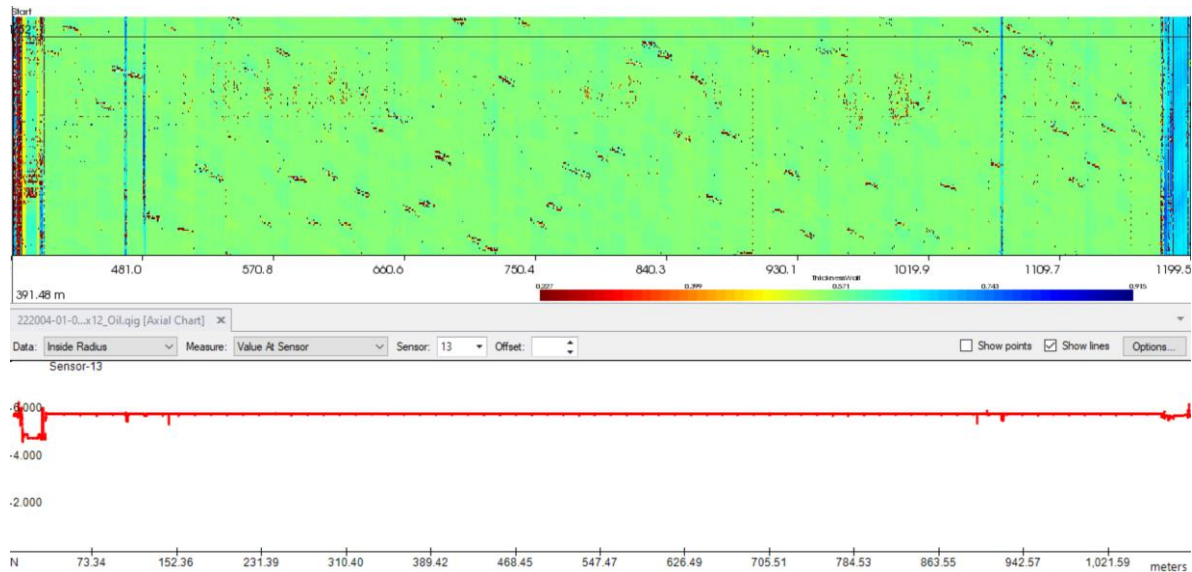
Figure 3: Wall thickness and inside radius view of the entire pipeline (with min. 9.5" ID)

Immediately after the run, the data was assessed by the on-site ILI inspection team and the minimum bore during the run was confirmed to be 9.5" (Fig. 3). With clarity regarding the minimum ID, a less conservatively sized tool could now be deployed into the line for the second stage to gain higher resolution data. This two-stage approach minimized the risk for the client and maximized the quality of the data collected.

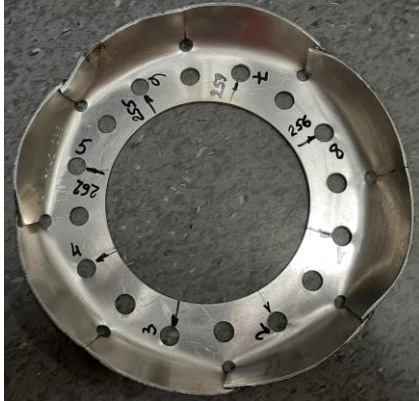
Although the documentation appeared to be up-to-date and with no indication of a reduced ID, the client suspected that a replacement with a reduced ID had been made without proper documentation. This was in part derived from the roundness of the reduction on the gauge plate (Fig. 4). The gauge pig (Fig. 5) had been set up with minimal clearance between the 305 mm diameter gauge plate and the pipe wall, measured at 311.4mm ID.

Figure 4: Measurement of the gauge plate

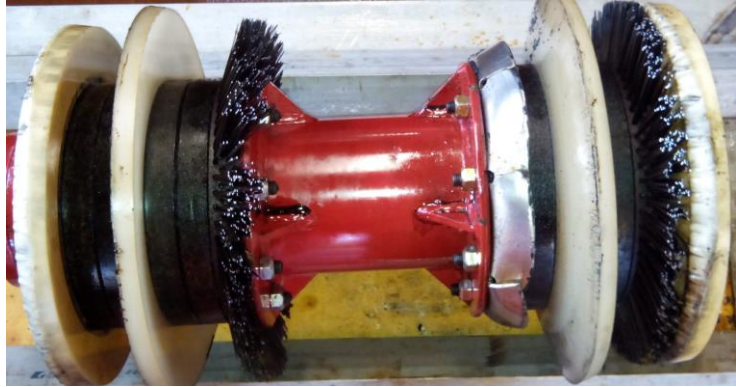
Figure 5: Standard Steel mandrel Gauge pig with added brushes

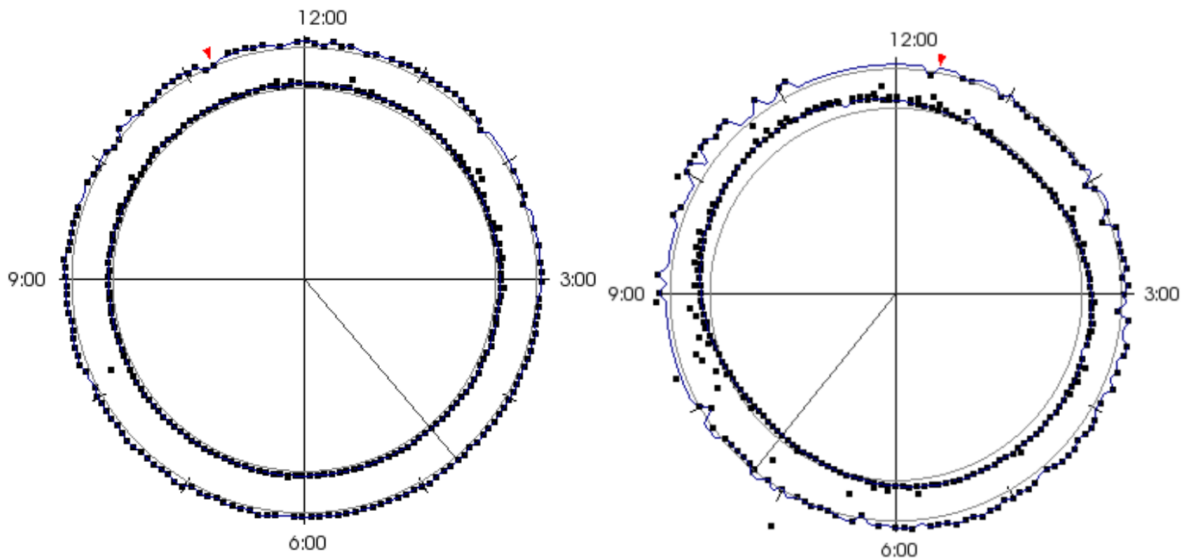
After performing the ILI run, the data was assessed onboard the platform in order to identify the reduction(s) in the bore. Ovality was observed all throughout the main pipeline between the platforms (Figs. 7 and 8). This could have occurred during the installation of the pipeline via a pipe laying vessel.

Figure 7: Cross section of the riser pipe (left) and main pipeline on the sea floor (right)

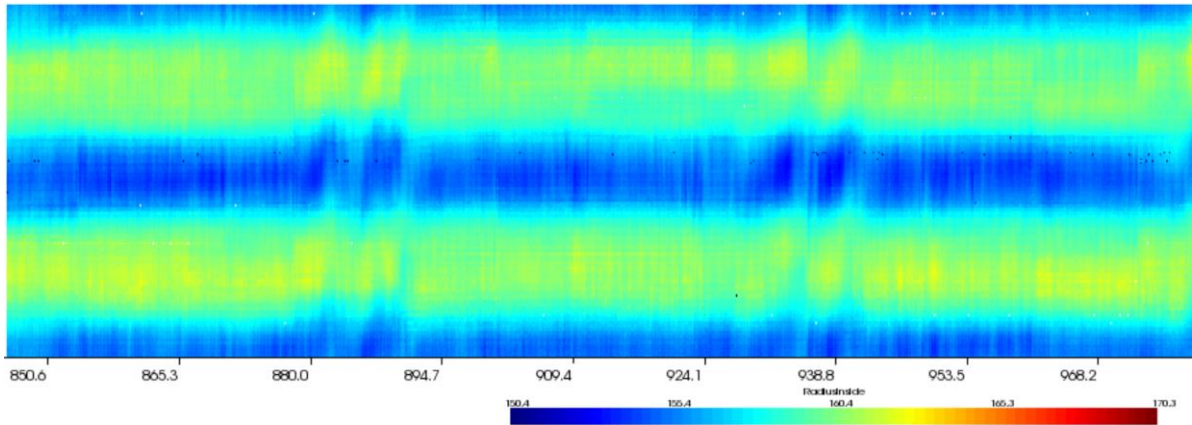
Figure 8: Ovality was encountered for the entire length on the seabed
