PIPELINE LIFE EXTENSION USING CUSTOM BUILT INSPECTION TOOLS

Primary Author: Holger Kamps, 3P Services GmbH & Co. KG, Germany

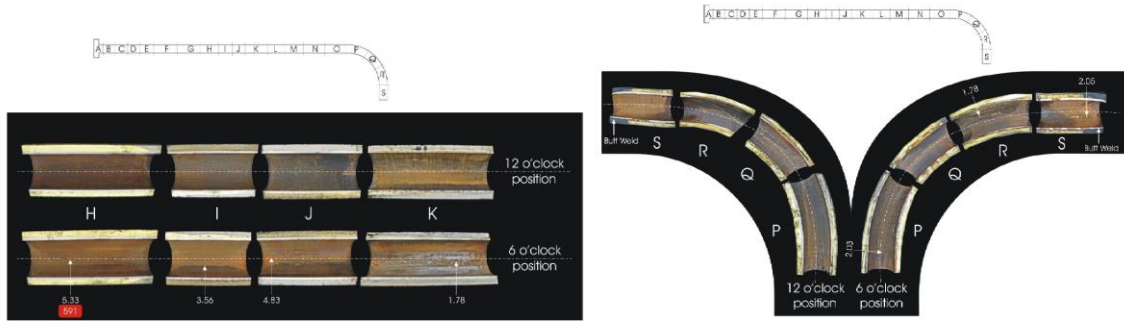
After detailed review of the ILI report in 2013 a rigid pipe section was replaced by a new 12" flexible piping. A part of the removed pipe section was deeply investigated. A spool where severe spots of corrosion were reported was examined using different measuring methods.

Figure 14-15: Removed spool piece sections

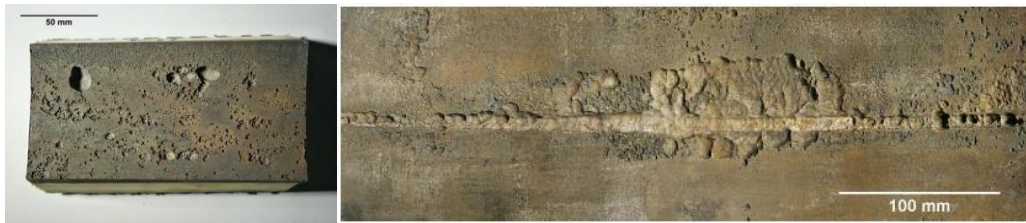
Figure 16-17: Pitting corrosion (left) and girth weld corrosion (right)

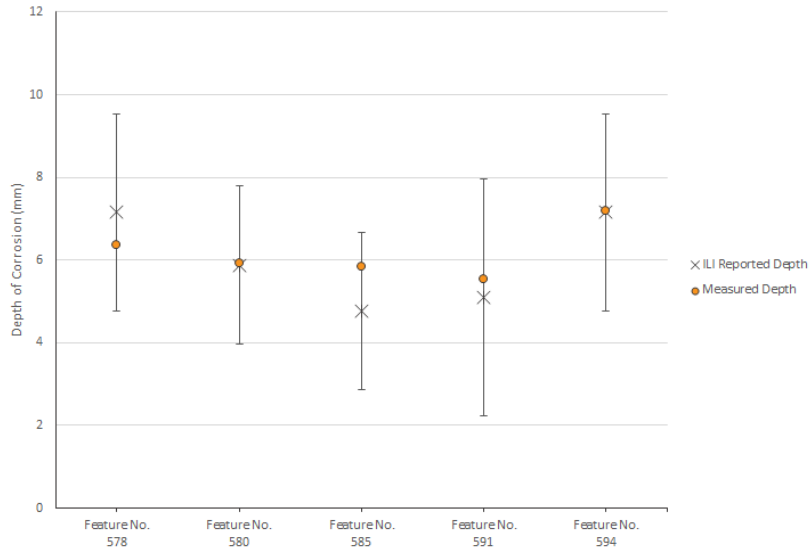
A pit depth gauge, further 3D laser scanning and metallographic sections advised that the ILI measurements were proper and verified within the applicable tolerances of the tool.

Figure 19: Comparison reported depth vs. measured depth
