COMPOSITES - CASE STUDIES OF PIPELINE REPAIR APPLICATIONS

By Andrew J. Patrick, Clock Spring Company, L.P., Huntingdon, UK

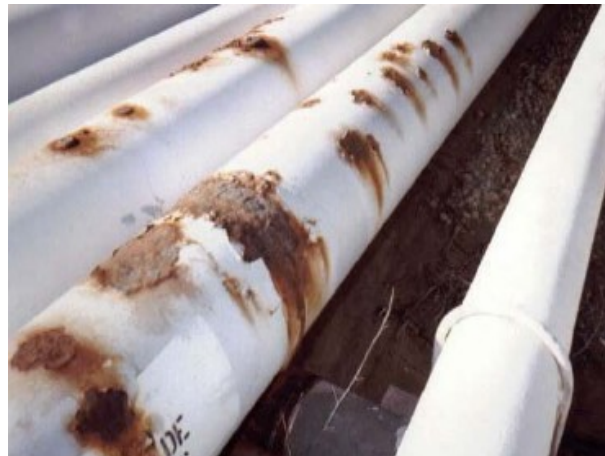
Figure 2

A corrosion cell can find its way to a pipeline not only through the ground but also by air. A refinery in the USA had major external corrosion (up to 80% metal loss) on a 12" (300 mm) pipeline caused by airborne drift from a cooling tower (Figure 2). The total length of the effected area was in excess of nine hundred feet (270 metres).

A composite reinforcement provided a logical alternative. Use of a composite repair eliminates the need for hot work, shut down of the pipeline, environmental exposure and the repairs could be installed within the tight clearances available.

In total 903 composite repairs were installed at a rate of 75 to 100 units per day using three x two man installation crews.

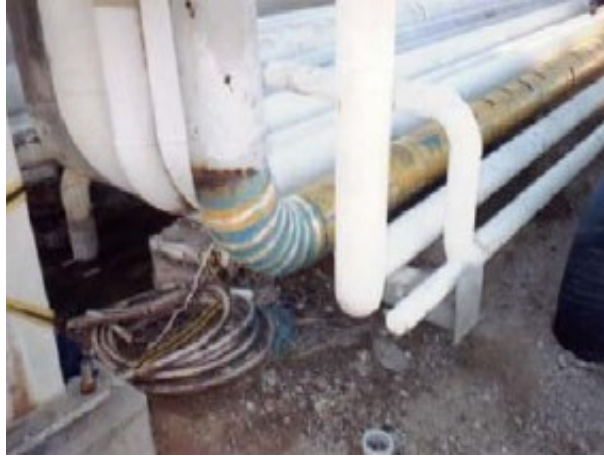
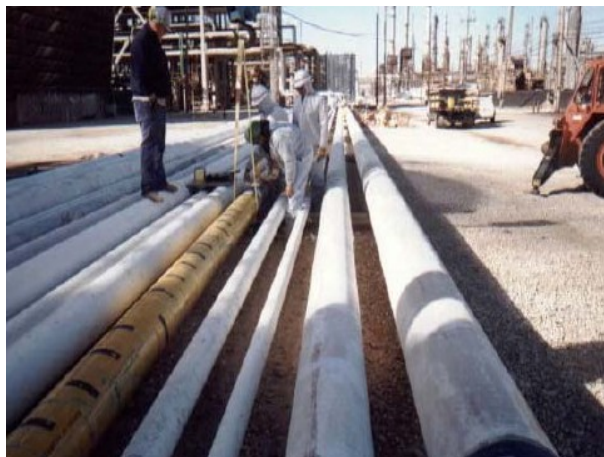
The repairs included straight pipe lengths as well as 45° and 90° degree elbows (Figures 3 and 4).

The composite repair not only provides proven permanent reinforcement but also corrosion protection to the pipeline from the effects of the continual airborne drift and vapour from the cooling towers.

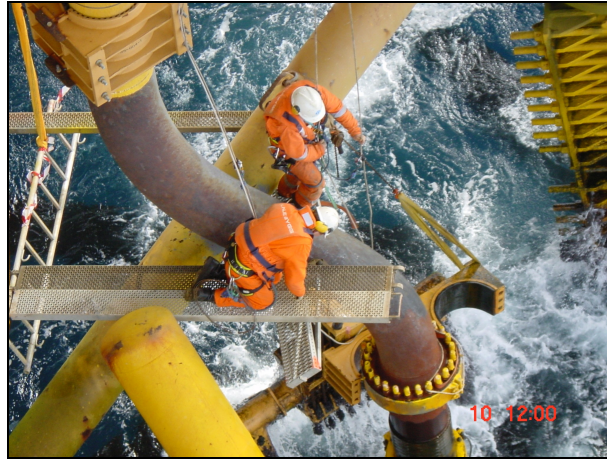
Figure 5

Due to platform subsidence it was found that as a number of risers were slowly sinking significant corrosion had developed above the original corrosion protection of the initial splash zone.

Replacement of the riser sections was considered but would have incurred two major problems, one a shut down of the platform and substantial production loss and secondly lengthy deliveries of the replacement section as the effected areas were on 3-D bend sections (Figure 5).

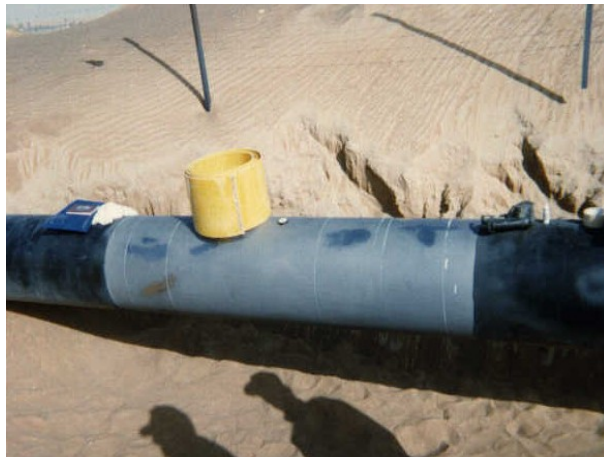
The excavator had "caught" the pipeline in three locations causing three significant gouges.

Figure 7 shows the pipeline after the gouges have been dressed and inspected. A composite sleeve is shown prior to being installed.

- The scrape or gouge is ground to a smooth contour to remove all stress concentrators. The maximum safe depth of grinding is 40% of the wall thickness.

- The damaged area is inspected to verify that any cracks have been removed by grinding.
- The residual indentation is filled with a hardenable filler for load transfer under the composite sleeve.

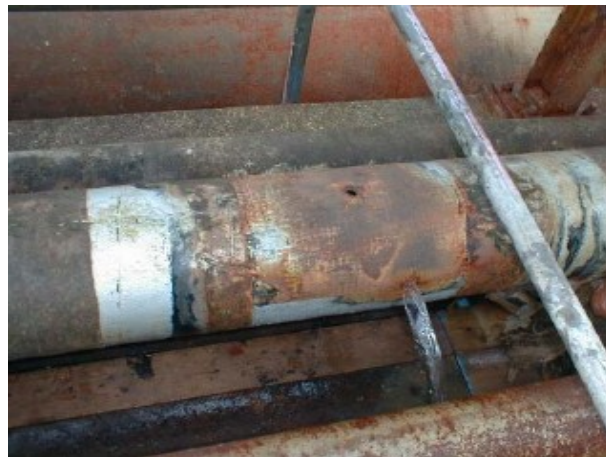
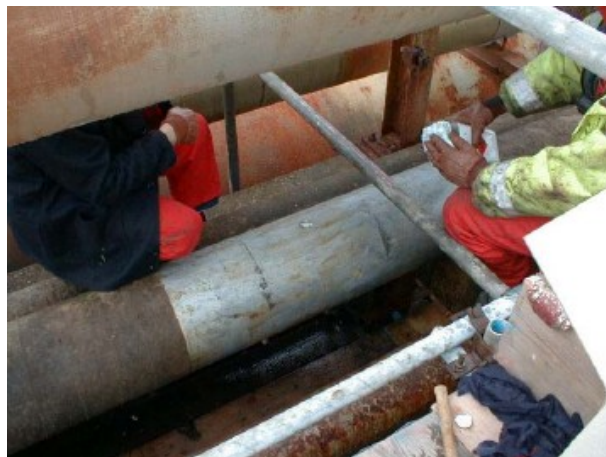
El-Segundo - California, a 24" (600 mm) crude oil, tanker offload pipeline used to supply a major tank farm was found to be leaking in several locations.

Once done the residual leak can be plugged (Figures 9 and 10) and the pipe surface cleaned.

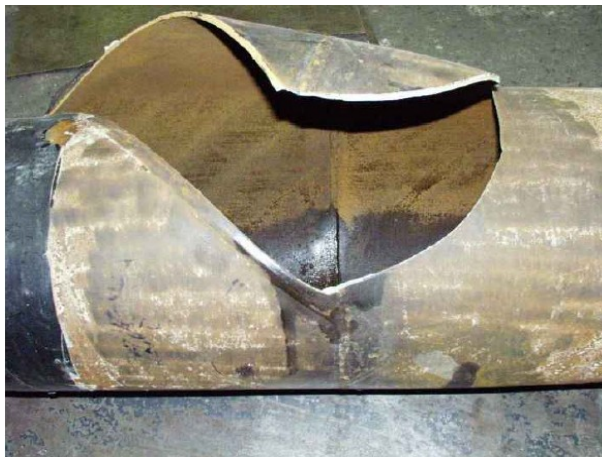
Figure 15 shows the results of a pressure test on an un-repaired girth weld section.

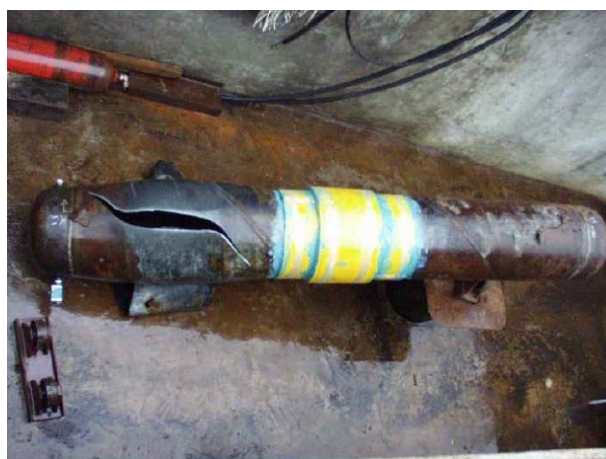
Figure 16

In all instances failure of the pipe occurred outside of the repair area (Figure 16) in the main wall of the pipe and at pressures significantly higher than the pipeline MAOP.

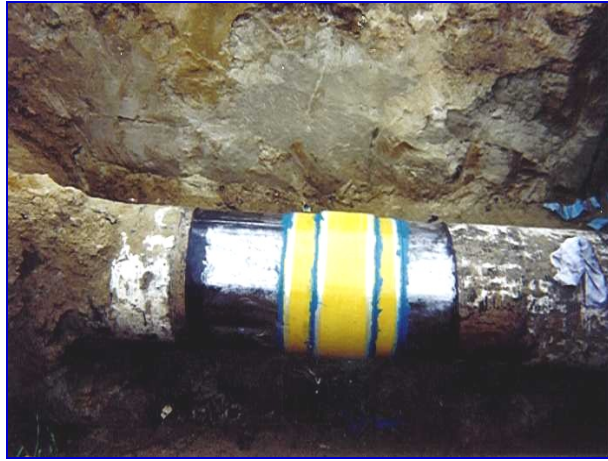
Figure 17

Further inspection of the girth welds identified the defects as being associated with the weld and included anomalies such as: lack of side wall fusion, porosity, pipe wall misalignment.

Following the results of this test work composite repairs have now been used in considerable numbers for girth weld reinforcement in areas such as Eastern Europe and the Former Soviet Union (Figure 17).
