Effective management of geohazard threats in pipelines

Derek Storey, Bipin Thomas, Suji Kurungodan,
Inspipe Integrity Ltd, UK
(www.inspipe.net)

Pranav Pasari, Satsense Solutions Ltd, UK
(www.satsense.co)

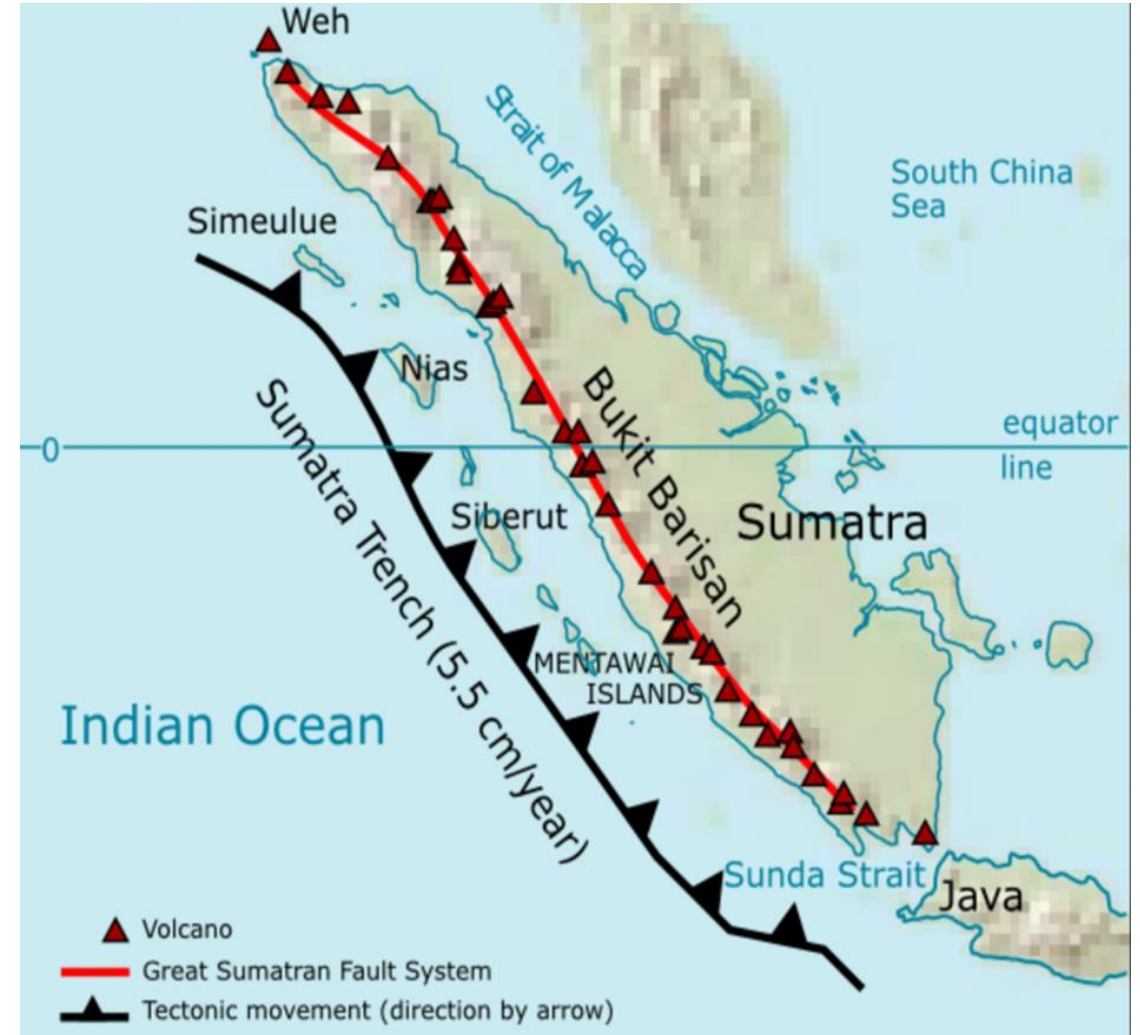
Major Tectonic Features of Sumatra

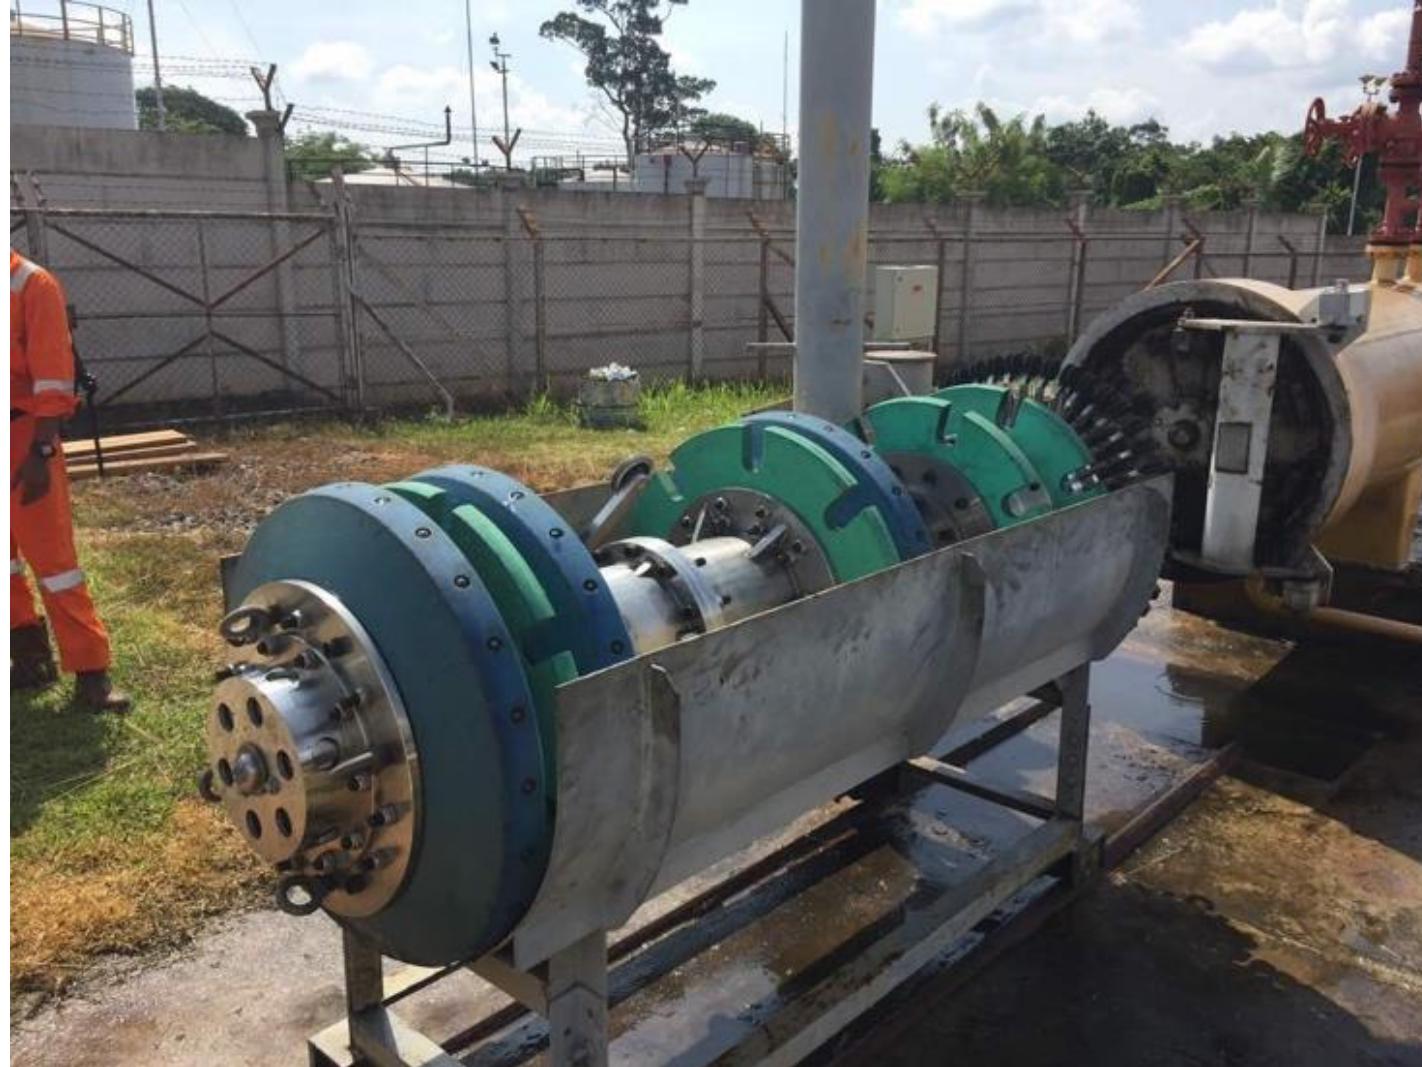
Receiving the 28" High Resolution Geometry + IMU Survey Tool

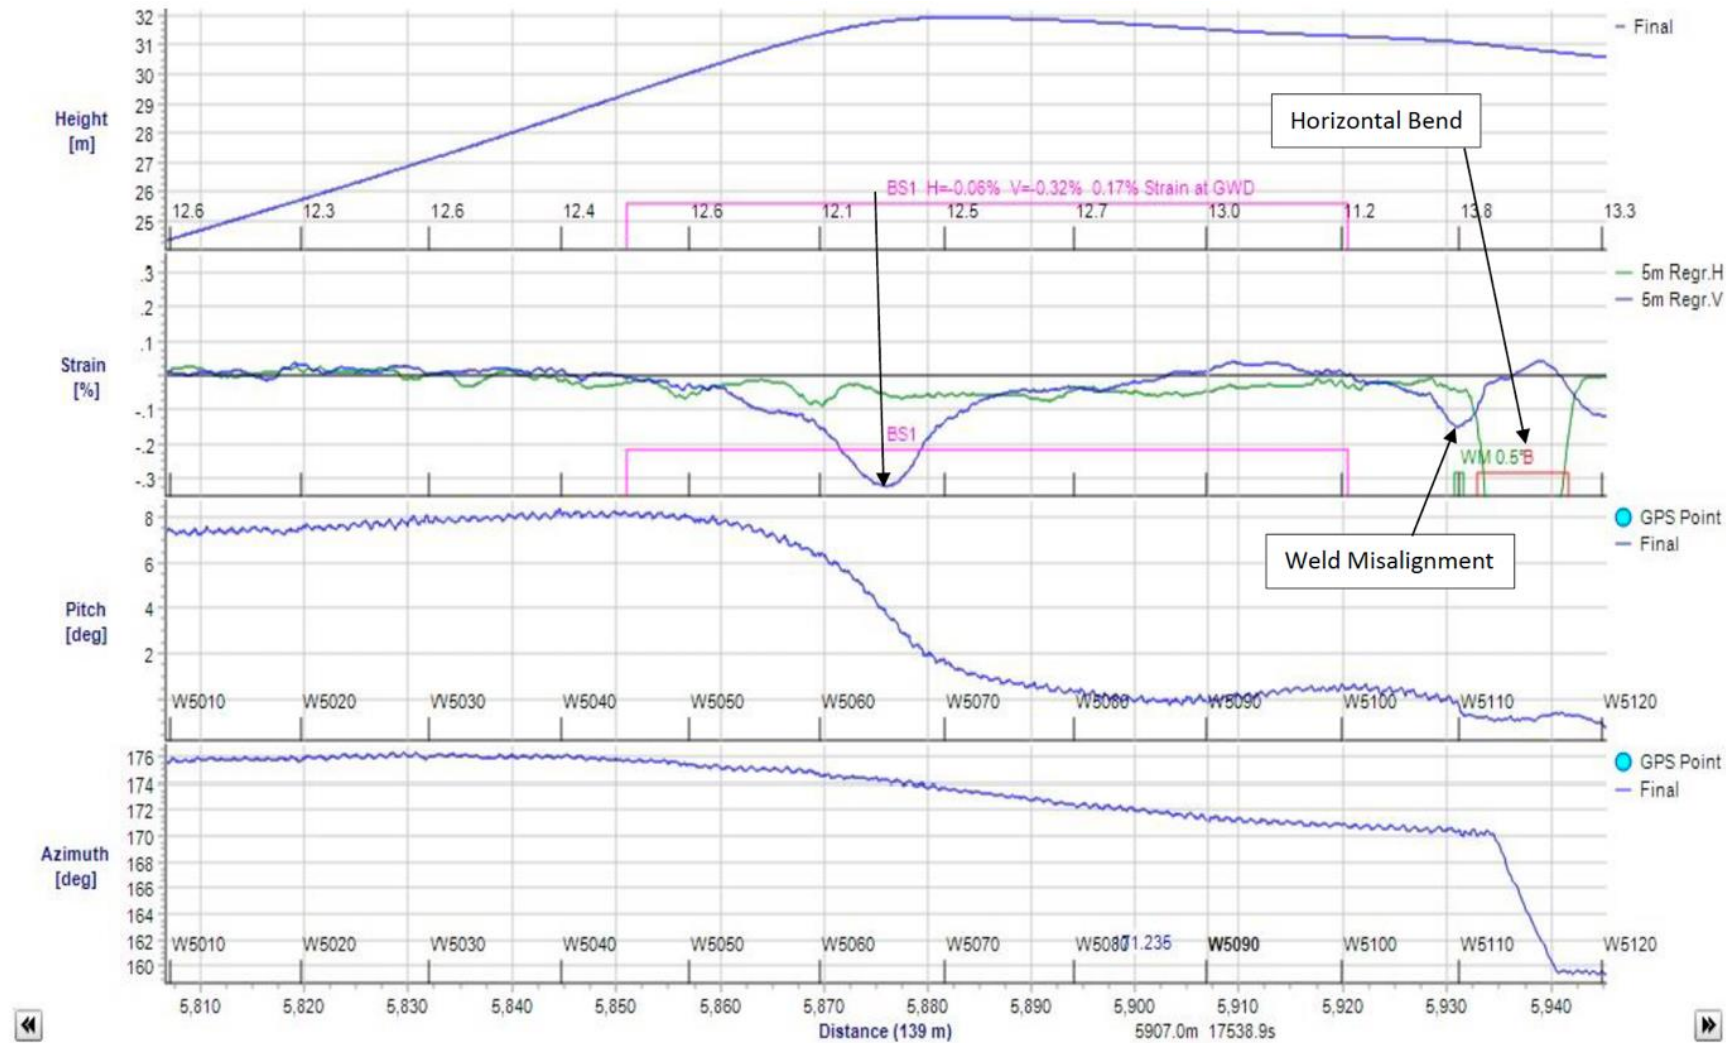
Plots of Bending Strain for Feature BS1 (Max. Bending Strain 0.33%)

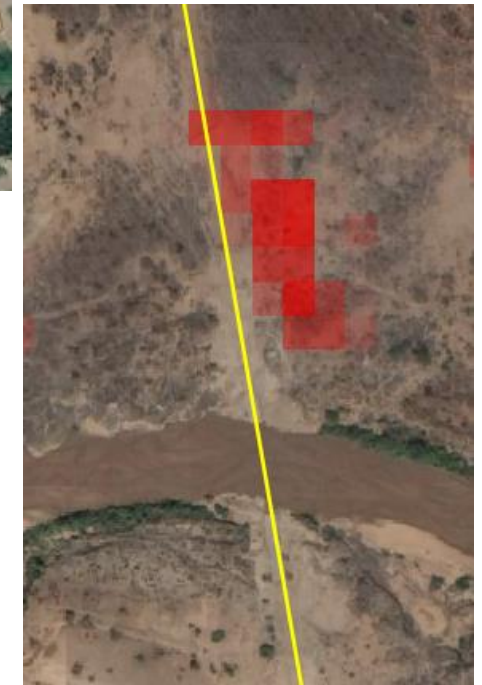
Clockwise from Top, Hydro-technical (Channel Migration), Erosional (ROW Washout) & Seismic (Faults).

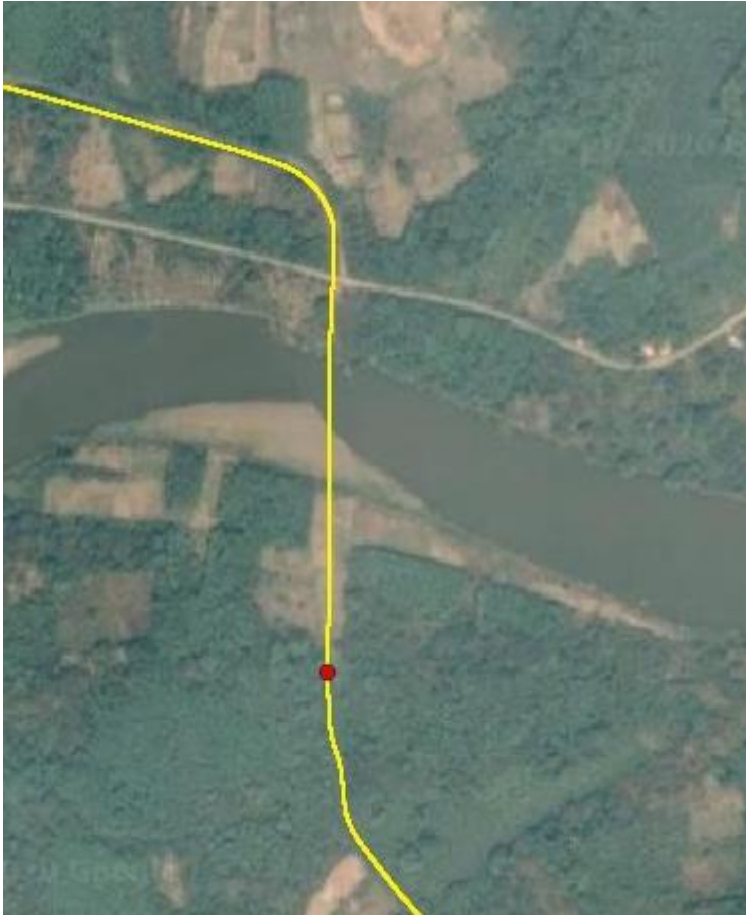
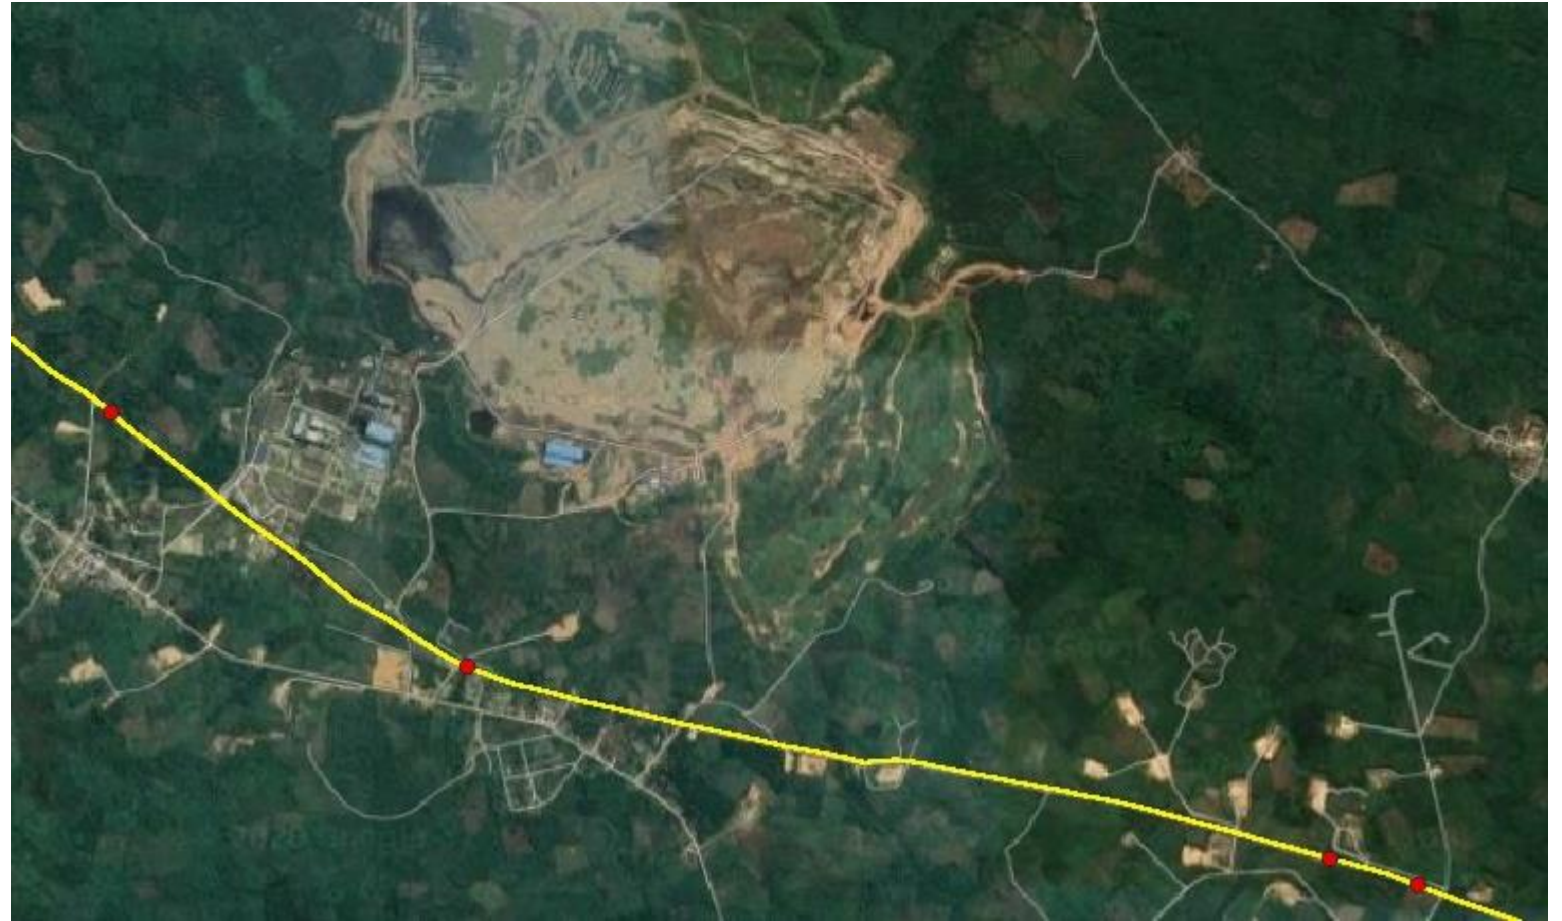
Location of Bending Strain Areas identified from IMU Analysis
