COMPOSITES - CASE STUDIES OF PIPELINE REPAIR APPLICATIONS

By Andrew J. Patrick, Clock Spring Company, L.P., Huntingdon, UK

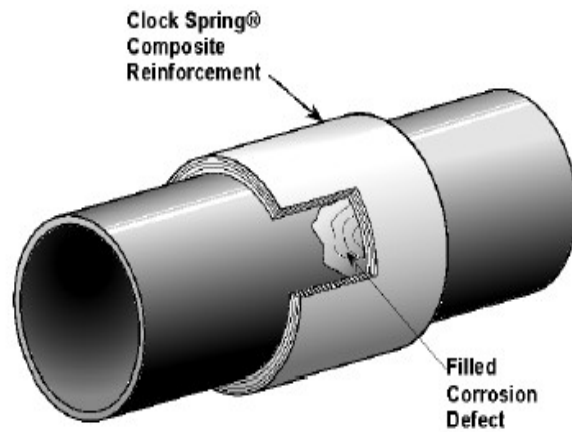
Figure 1

- The composite structure.
- An adhesive system used to bond the composite to the pipe and to each successive layer of the applied wrap.
- A high compressive strength load transferring compound applied into the defect. (Figure 1) shows a Clock Spring composite repair.
